YUBA COMMUNITY COLLEGE DISTRICT

FACILITIES MASTER PLAN

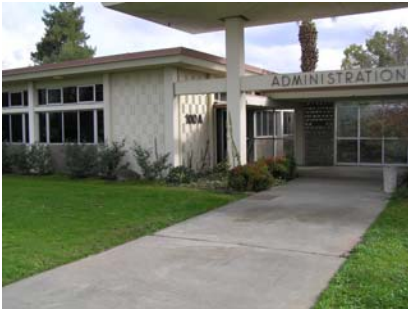
Building 100A – Administration

Conditions: The building has a number of physical deficiencies. The composition roof is in poor condition and needs replacement. The ceiling tiles are in need of replacement in most areas. The floors, which are primarily carpeted, are stained and worn and in need of replacement in some areas of the building. Toilet separation compartments in the restrooms are metal and need to be replaced. The electrical panel boards, wires and receptacles are original and need to be replaced. The building also lacks an emergency generator and a fire sprinkler system.

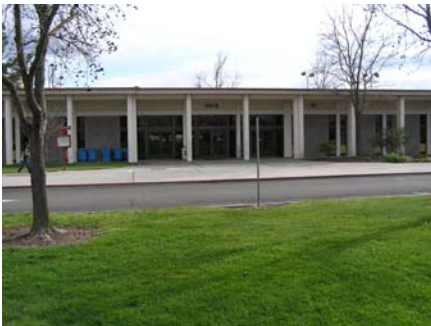
Building 100B – Student Services

Conditions: The composition roof is in poor condition and needs to be replaced. The ceiling tiles are in need of replacement in most areas. The floors, which are primarily carpeted, are stained and worn. Toilet separation compartments in the restrooms have deteriorated and are in need of replacement. The electrical panel boards, wires and receptacles are original and need to be replaced. The building also lacks an emergency generator and fire sprinkler system. Exterior signage needs to be improved.

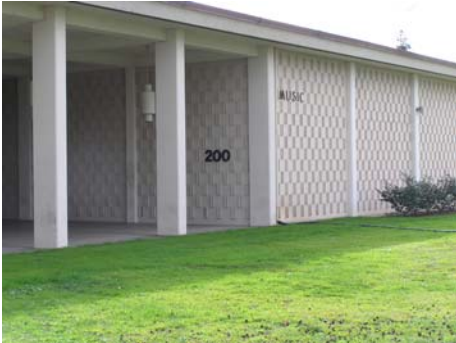
Building 200 – Music

Conditions: The composition roof is in poor condition and needs replacement. The glue-on ceiling tiles are in need of replacement in some areas. The 9 x 9 inch floor tile should be replaced in the building as they contain asbestos. Emergency lights are not present. In addition, the electrical panel boards, wires and receptacles are original equipment and need to be replaced. The building does not have an emergency generator. The building only has a fire sprinkler system in storage areas and in restrooms.

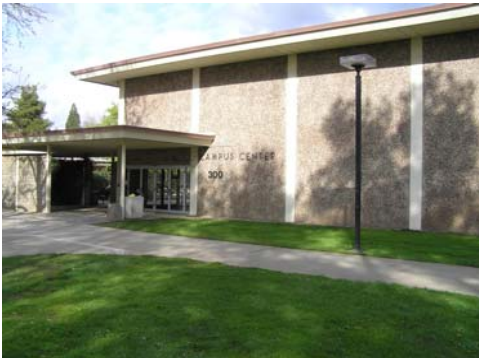
Building 300 – Campus Center

Conditions: The roof is wood framed with a wood decking, built-up composition roof system. The composition roof is in poor condition and needs replacement. The storefront glass doors are beyond their useful life and need replacement. The ceiling tiles are glue-on and in need of replacement in some areas. The carpet is stained and worn and in need of replacement in many areas throughout the building. The kitchen areas for both the Food Service Management program and the Cafeteria need to be renovated, with additional electrical outlets added. The Food Service Management program floor tiles need to be replaced. A shared dishwashing station needs to be added as well as a sound-proof wall between Flavors Restaurant and the Multipurpose Room. The Cafeteria needs to be renovated to improve traffic flow by removing the center island, serving and cash register stations. Restroom toilet compartments are metal and need to be replaced. Plumbing fixtures are in fair condition and the copper piping is original. Panel boards, wires and receptacles are original and need to be replaced. The building does not have an emergency generator.

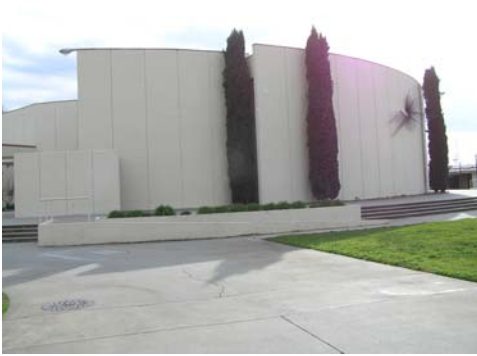
Building 400 – College Theatre

Conditions: The structure is in fair condition. The heavy use of this facility has taken its toll. The roof is wood framed with a wood decking built-up composition roof system. The composition roof is in poor condition and needs replacement. The glue-on ceiling tile is in need of replacement in some areas. The 9 x 9 inch floor tile is beyond its useful life and needs replacement as it contains asbestos. The carpet is stained and worn and in need of replacement. The lighting dimmer board is over thirty years old and needs to be replaced. Restroom toilet compartments are metal that are in need of replacement.

Plumbing fixtures are typically in fair condition and copper piping is original.

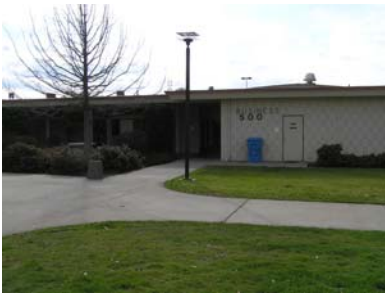
Building 500 – Business/Social Science

Conditions: The composition roof is in poor condition and needs replacement. The glue-on ceiling tile is in need of replacement in some areas. Floors are primarily tile and carpet. The 9 x 9 inch floor tile is beyond its useful life and needs replacement as it contains asbestos. The carpet is stained and worn and in need of replacement in the building. Plumbing fixtures are in poor condition; toilet compartments are metal and are in need of replacement. Electrical panel boards, wires and receptacles are original and need to be replaced. Emergency lights and emergency exit signs are not present. In addition, the building lacks both an emergency generator and a fire sprinkler system.

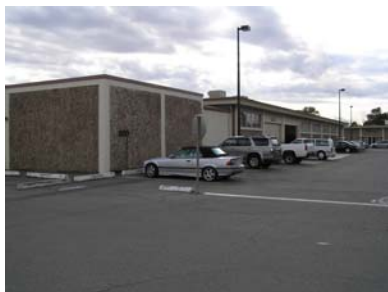
Building 600 – Applied Arts/Sciences

Conditions: The composition roof is in poor condition. The roll-up doors to the class lab areas are beyond useful life and need replacement. The 9 x 9 inch vinyl tile needs replacement as it contains asbestos. The carpet and concrete floors are stained and need refinishing. The restroom toilet compartments are metal and need to be replaced. Ceiling-mounted exhaust fans are installed in restrooms and ventilation is inadequate. Plumbing fixtures are in poor condition and copper piping is original. Electrical panel boards, wires and receptacles are original and need to be replaced. In addition, the building does not have an emergency generator and only has a fire sprinkler system in storage areas and restrooms. Additional classroom space to accommodate larger lectures would enhance the instructional programs.

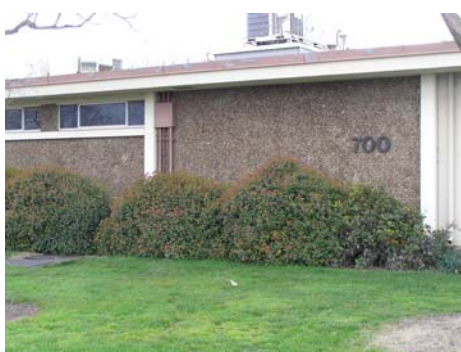
Building 700 – Mathematics/Engineering/Science

Conditions: Building 700 demonstrates clear evidence of deterioration. The conditions of the rooms are generally poor and renovations are clearly needed including access to the area occupied by the Administration of Justice program. Many rooms and restrooms lack adequate heating and ventilation (HVAC). The restrooms lack running hot water and have plumbing issues. Other deficiencies include glue-on and drop-in ceiling tiles that are in need of replacement throughout the building and concrete floors that are stained and need refinishing. The vinyl composition tile (VCT) is worn and damaged throughout the building and needs replacement. The original electrical panel boards, wires and receptacles need to be replaced. The building lacks emergency exit signs, an emergency generator and a fire sprinkler system. The Math, Engineering, Science Achievement Program (MESA) and Hard Math Café (tutoring/study center) are in need of additional space and is an important element for the continued success and expansion of the programs. The Engineering lab needs to be renovated and faculty offices should be enlarged. The building is in need of fully equipped classrooms, a conference room and labs that are well equipped and properly designed.

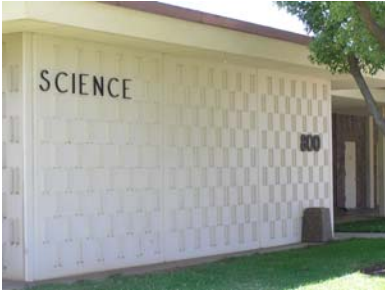
Building 800 – Life and Physical Sciences

Conditions: A complete renovation of this building currently is underway with a scheduled completion date of August 2006.

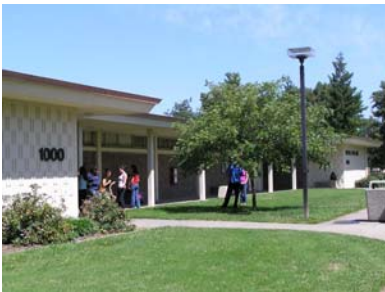
Building 1000 – Liberal Arts Center

Conditions: The ceilings are composed of glue-on ceiling tile and drop-in tile in metal grids with 2 x 4 foot ceiling tiles. The glue-on ceiling tiles are dated and in need of replacement in most areas. The 9 x 9 inch floor tile is stained and worn and is in need of replacement throughout the building as it contains asbestos. Restroom toilet compartments are metal that are in need of replacement. Ceiling-mounted exhaust fans are installed in restrooms and ventilation is inadequate. Plumbing fixtures are typically in poor condition and copper piping is original. The heating, ventilation, air conditioning unit (HVAC) is in need of replacement. Emergency signs are not present. Panel boards, wires and receptacles are original and need to be replaced. The building does not have an emergency generator.

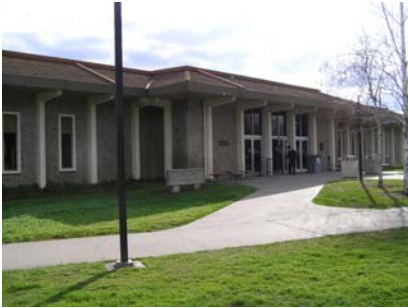
Building 1100 – Learning Resources Center

Conditions: There are a number of deficiencies that are associated with this building. The composition roof is in poor condition and needs to be replaced. The exterior walls have aluminum storefront doors that are beyond useful life and need replacement. The service doors are flat-faced steel in steel frames that need replacement. The glue-on ceiling tile needs replacement in most areas. The floors are primarily carpet that is stained and worn and is in need of replacement throughout the building. The toilet compartments are in need of replacement. Ceiling-mounted exhaust fans installed in restrooms provide inadequate ventilation. The electrical panel boards, wires and receptacles are original and need to be replaced. In addition, the building, which is heavily used, does not have a fire sprinkler system.

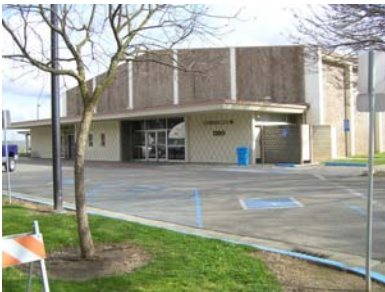
Building 1200 – Gymnasium

Conditions: The roofs are wood framed with a wood decking built-up composition roof system. The composition roofs are in poor condition and need to be replaced. Walls throughout the building are in need of painting and lighting needs to be replaced. The exterior walls have aluminum storefront doors that need replacement. Service doors are flat-faced steel-in-steel frames that are damaged and beyond useful life and need to be replaced. Walls throughout the building are in need of painting. Glue-on ceiling tiles are in need of replacement in some areas. Concrete floors are stained and in need of refinishing throughout the building. The 9 x 9 inch floor tile is outdated and in need of replacement as it contains asbestos. Hardwood flooring is worn and in need of refinishing. Restroom toilet compartments are metal that are in need of replacement. Ceiling-mounted exhaust fans are installed in restrooms and ventilation is inadequate. Plumbing fixtures are in fair condition and copper piping is original. Panel boards, wires and receptacles are original and need to be replaced. The building does not have an emergency generator. The soccer and football fields as well as the track need to be renovated. The pool and tennis courts are unusable.

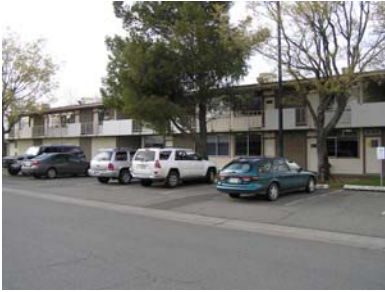
Building 1300 – Collins Hall

Conditions: The roof structure is a wood framed with wood decking and built-up composition roof system. The structure is in fair condition as is the roofing system. Exterior doors and aluminum windows are dated and show signs of air infiltration and require replacement. Electrical panels are outdated and in need of replacement. Current overhead lighting is inadequate. The building does not have an emergency generator, emergency exit signs or a fire sprinkler system. Several places in the building are not adequate for proper instruction or office locations. ADA accessibility is nonexistent on the second floor.

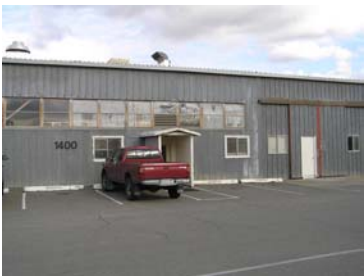
Building 1400 – Maintenance

Conditions: This building has a number of physical deficiencies such as the roof system that requires replacement, the single-pane windows that are dated and need replacement, the concrete floors that need refinishing, the ceiling-mounted exhaust fans in the restrooms that are inadequate, the plumbing fixtures that are in poor condition and the electrical panel boards, wires and receptacles that are original and need to be replaced. The interior wall finishes are gypsum board that are generally in fair condition. The building also lacks an emergency generator, emergency lights, emergency exit signs and a fire sprinkler system.

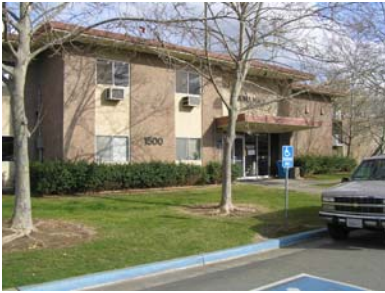
Building 1500 – Osuna Hall

The majority of the deferred maintenance requirements are of the type that can be repaired or refurbished without demolition of facilities (e.g., mechanical and electrical systems, wall and floor finishes and exterior doors and windows). Not all facilities should be renovated. As a case in point, it is recommended that Yuba College, Marysville, demolish Osuna Hall, Building 1500.

Conditions: The structure is in fair condition. Some of the physical deficiencies noted include the roof system that is in poor condition and needs replacement, the exterior doors and aluminum windows that show signs of air infiltration and require replacement and the carpet and flooring that is dated and needs to be replaced. In addition, approximately half of the dormitory rooms have the building's original gas-fired wall heaters and window air conditioner units. These older heaters and AC units are failing and need to be replaced with heat pump units. Other deficiencies include the ceiling-mounted exhaust fans that are installed in restrooms and provide poor ventilation. The plumbing fixtures are in poor condition and the copper piping is original. The building also lacks emergency exit signs, an emergency generator and a fire sprinkler system.

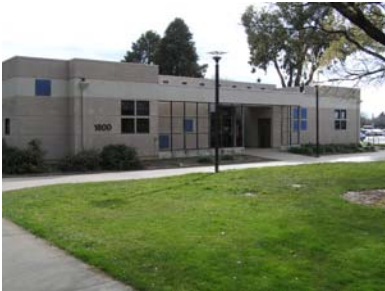
Disabled Student Services Center

Conditions: The building lacks emergency generators and a fire life safety system. The composition roof is in fair condition with some signs of water intrusion. Ceiling tiles are stained and in need of replacement. Restrooms are in poor condition and in need of significant repairs.
