YUBA COMMUNITY COLLEGE DISTRICT

FACILITIES MASTER PLAN

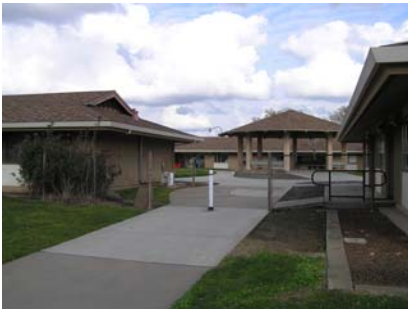
Building 1600 – Warren Hall

Facility Description: Warren Hall is located on the east side of the campus. The five building, one-story, 13,026 square-foot building complex houses class lecture space, laboratory space, offices and child development space. The buildings are permanent facilities. They were originally constructed in 1966 as dormitories. There have been no additions or renovations to the buildings.

Conditions: Some of the deficiencies found throughout this building include the interior walls that need repainting, the outdated floor tile that needs replacement as it also contains asbestos and electrical panel boards, wires and receptacles that need to be replaced. Carpet needs to be installed in the Radiologic Technology classroom to help with acoustical issues. Exterior doors and aluminum windows are dated and show signs of air infiltration. The aluminum windows for the building need replacement. The heating, ventilation, air conditioning unit (HVAC) needs to be replaced. Plumbing fixtures are in poor condition and copper piping is original. The building also lacks emergency exit signs and an emergency generator.

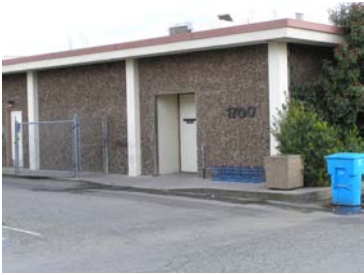
Building 1700 –

Conditions: The physical deficiencies include plumbing fixtures that are in poor condition and electrical, panel boards, wires and receptacles that are original and need to be replaced. The interior wall finishes are gypsum board that are generally in fair condition. The concrete floors are stained and need refinishing. The building also lacks plumbing, emergency lights, an emergency generator and a fire sprinkler system and covered parking for the emergency vehicles.

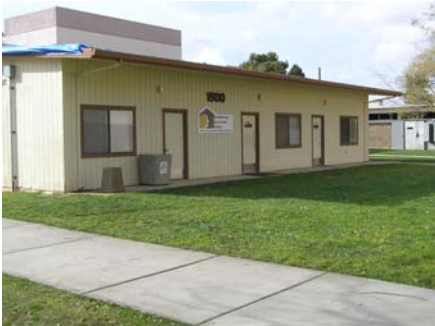
Building 1900 - Distributive Education

Conditions: The wall covering is damaged and needs replacement. Ceilings are suspended drop-in 2 x 4 foot tiles in metal grids that are damaged in some areas. Flooring is vinyl composition tile (VCT) that is dated and needs replacement. The building also lacks plumbing, emergency lights, emergency exit signs, an emergency generator and a fire/life safety system.

Conclusion: The building has an FCI rating of 6.48%.

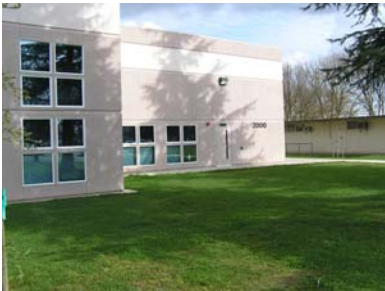
Building 2000 – Adaptive Physical Therapy

Conditions: Being relatively new, this building has few deficiencies. However, the building is in need of signage and a shower in the spa room.

Conclusion: This building is in good condition. No FCI rating has been assigned.

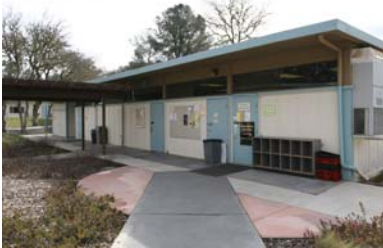
Building 100 – Student Center

Conditions: The overall building structure and exterior components are in fair condition. The exterior doors and aluminum-framed windows are dated and show signs of air infiltration. The windows are single-pane glass set in aluminum frames. The ceiling-mounted exhaust fans installed in the restrooms provide inadequate ventilation. There are no emergency lights, emergency generator or lighted emergency exit signs. The fire alarm system installed consists of audible and strobe annunciators in offices and other common spaces but does not have a fire sprinkler system.

Conclusion: The building has an FCI rating of 107.54% and is beyond its useful life.

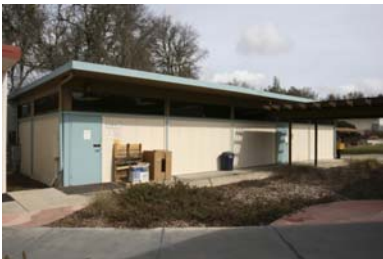
Building 200 – Library

Conditions: The overall building structure and exterior components are in fair condition. The building does not have plumbing. It does not have emergency lights, lighted emergency exit signs, an emergency generator or a fire sprinkler system. The floor is bowed in the center and the carpet is more than 15 years old. The library is not equipped to utilize the latest technologies. Development of a plan to address the space constraints in the present Library and to ensure ADA compliance needs to be completed.

Conclusion: The building has an FCI rating of 107.33% and is beyond its useful life.

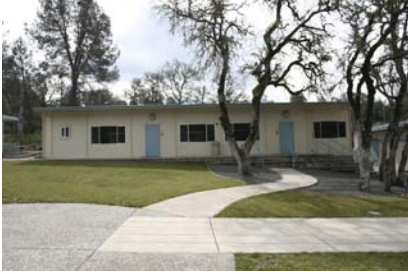
Building 300 – Science/Learning Disabled

Conditions: The overall building structure and exterior components are in fair condition. Exterior doors and aluminum-framed windows are dated and show signs of air infiltration. The building has emergency lights, but does not have emergency exit signs, an emergency generator or a fire sprinkler system. The building is small and cramped for the many services and programs housed there making ADA compliance an issue and challenge. A science laboratory is needed.

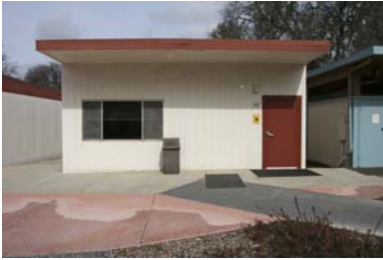
Building 701-702

Conditions: The exterior doors and aluminum-framed windows are dated and show signs of air infiltration. The complex does not have any plumbing. Emergency lights or exit signs are not present. The complex also does not have a fire sprinkler system to complement the fire alarm in place. The rooms lack adequate equipment and technology infrastructure.

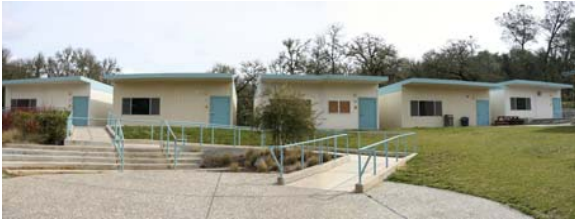
Building 901 – 908 Classroom Center

Conditions: The exterior doors and aluminum-framed windows are dated and show signs of air infiltration. Also noted is the lack of emergency lights and emergency exit signs. In addition, the complex does not have a fire sprinkler system to complement the fire alarm. Digital cabling and quieter HVAC units are needed in each classroom. Current HVAC units are loud and interfere with the delivery of classroom lectures. In order to rectify this problem, bringing improved utilities, such as natural gas, to the campus will be necessary to allow for more efficient and quieter HVAC systems to be utilized.

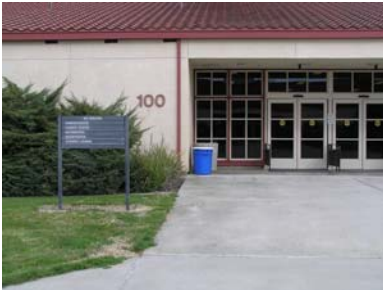
Building 100 – Administration

Conditions: The building's foundation is a reinforced concrete slab on grade with deepened perimeter footings that shows some signs of settlement or damage. The roof's structure is wood-framed with a mission clay tile roof system that is failing, leaks and needs replacement. Walls in most areas of the building are in need of painting and the ceiling tiles in some areas are dated and in need of replacement. The carpet is worn, stained and in need of replacement. The heating/cooling distribution system is a 2-pipe system using 10 fan coil units. The 2-pipe system is damaged and needs to be replaced. Plumbing fixtures are in poor condition and copper piping is original with upgrades needed in the restrooms. The building does not have an emergency generator.

Conclusion: The building has an FCI rating of 24.92%.

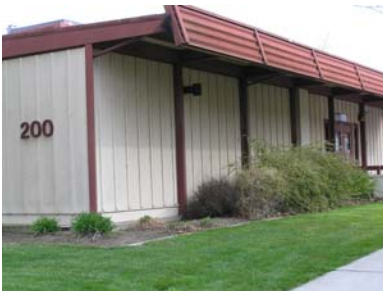
Building 200 – Bookstore

Conditions: Ceilings are damaged in some areas and need to be replaced. Flooring is carpet that is soiled and needs replacement. The building does not have plumbing, emergency exit signs, an emergency generator or a fire sprinkler system.

Conclusion: The building has an FCI rating of 11.53%.

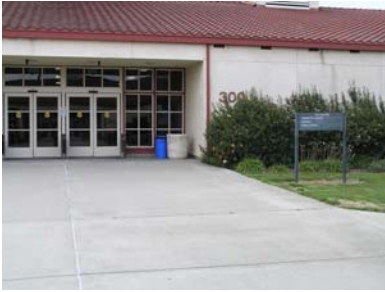
Building 300 – Laboratory/Classroom

Conditions: The building's foundation is a reinforced concrete slab on grade with deepened perimeter footings that show some signs of settlement or damage. Most interior walls in all areas of the building are in need of painting and the ceiling tiles in some areas are dated and in need of replacement. The carpet is worn, stained and should be replaced. Roof drains and gutters are also in need of replacement. The building heating/cooling distribution system is damaged and needs to be replaced. Plumbing fixtures are in poor condition and the copper piping is original. There is no emergency generator.

Conclusion: The building has an FCI rating of 28.56%.

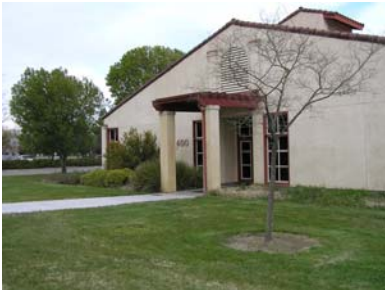
Building 400 – Laboratory/Agriculture

Conditions: The building's foundation is a reinforced concrete slab on grade with deepened perimeter footings that shows some signs of settlement or damage. The roof system leaks and is in need of replacement. It is also noted that the roof has been repaired twice and continues to have problems. Roof drains also are in need of replacement. Interior walls in some areas of the building are in need of painting. The ceiling tiles in some areas are dated and need to be replaced. In some areas the carpet is worn, stained and should be replaced. The heating/cooling distribution system is a 2-pipe system using 9 fan coil units that is damaged and needs to be replaced. The Agriculture greenhouse is in need of a maintenance upgrade. The lab sinks that are found within this building are in poor condition and the copper piping is original. The building does not have an emergency generator.

Conclusion: The building has an FCI rating of 26.28%.

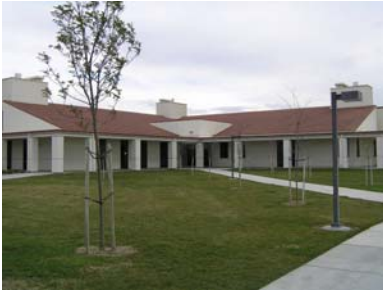
Building 600 – Sciences

Conditions: Being relatively new, this building has few deficiencies. Laboratories require some ventilation modification.

Conclusion: This building is in good condition. No FCI rating has been assigned.

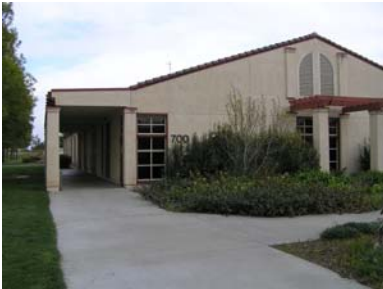
Building 700 – Library/Learning Resources/ Student Services

Conditions: The building foundation is a reinforced concrete slab on grade with deepened perimeter footings that shows some signs of settlement or damage. The roof structure is made of a wood frame with a mission clay tile roof which leaks and needs immediate replacement. Walls need to be repaired. Ceiling tiles are in need of repair and replacement in most areas. Some window frames leak during heavy rain, and water damage is evident throughout the northwest wing. The floors are smooth concrete, which are stained and in need of refinishing. The heating/cooling distribution system is a 2-pipe system, which is damaged and needs to be replaced.

Conclusion: Although this building has an FCI rating of 4.62%, it is in need of a roof replacement. The facility also needs other renovations to accommodate new programs.

After a thorough review of existing facilities, the faculty and staff have identified a list of repair and remodeling needs. Woodland Community College plans to replace the roof on Building 700 and renovate existing facilities to expand and co-locate all Student Services functions into an integrated Student Services Center. In addition, the plan calls for existing classrooms to be converted into “Smart” classrooms, and for other general repairs and upgrades to take place.

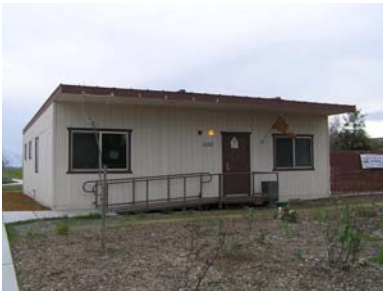
Building 1000 – Childcare

Conditions: The flooring is damaged and needs replacement. In addition, the building does not have an emergency generator or a fire sprinkler system. Wiring for internet access is being installed.
